TRANSPIRATION COOLING SYSTEM DEVELOPMENT FOR REENTRY VEHICLES

D2-114181-1

Space Division
THE BOEING COMPANY
Seattle, Washington

July 1968

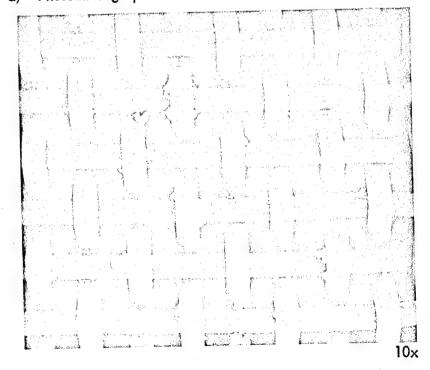
Table 3 summarizes the 11 coating runs conducted to develop techniques for coating of the screen components. The 6 hours at 2000°F coating conditions gave satisfactory coating thickness except at wire intersections. Figure 29 is a photomicrograph of a cross-section of the wire screen showing the thin coating at the wire intersections. Figure 29 shows a screen specimen after testing for one hour at 2500°F illustrating the failure initiation at the wire intersections.

b) Columbium screen subsequent to oxidation testing at 2500 °F.

Oxidation failure indicated by columbium oxide growing from wire intersections

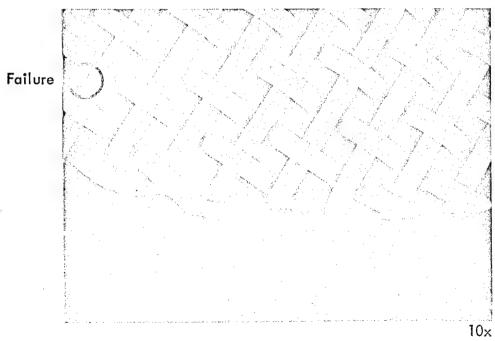
The appearance of a 2" diameter screen after oxidation testing for 10 cycles is shown in figure 31a. A typical minor oxidation failure can be seen in the photograph (figure 31b) of this screen taken at higher magnification.

b) Oxidation failure indicated by presence of columbium oxide
